Part A - Major Development Plan July 2007

appendices

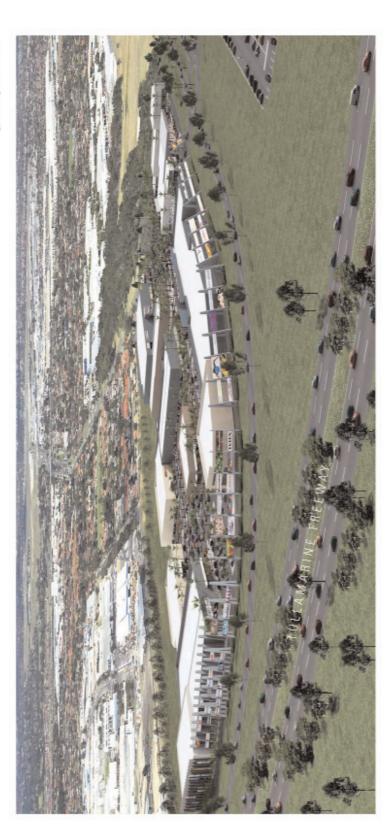
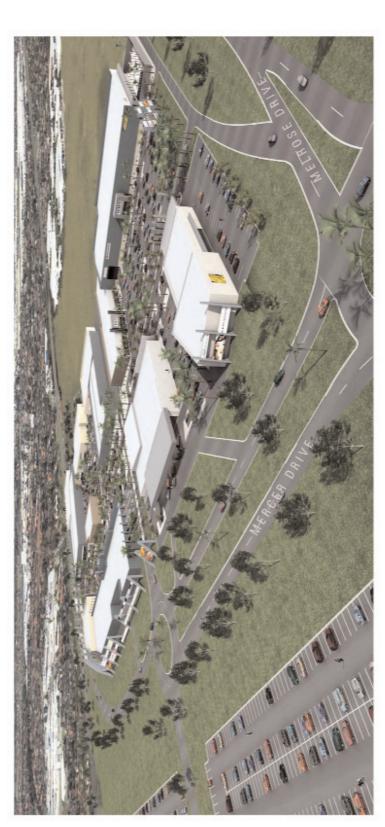
Appendix 3 Perspective drawings

perspective

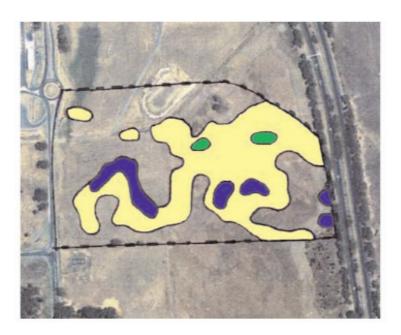
Vegetation Map

KEY TO MAP OF VISUALLY ESTIMATED WALLABY-GRASS COVER

GREEN: Wallaby-grasses ca. 15% average cover BLUE: Wallaby-grasses ca. 10% average cover YELLOW: Wallaby-grasses ca. 5% average cover

The density of wallaby-grasses varies in a patchy fashion across the site, presumably reflecting a combination of factors including effects of prior management, patterns of recolonization based around chance survival or re-establishment events, variation in soil and moisture characteristics, and recent disturbance events on the site. The local proportion of ground-cover provided by the genus was assessed visually and the site mapped into generalized zones based on average percentage cover (see map below).

Wallaby-grasses provided around 10-15% ground-cover over slightly in excess of 5% of the site, approximately 5% average cover over a little under 50% of the site, and were absent to providing less than ca. 1% average cover over the residue of the area (almost 50% of the site). The wallaby-grasses species providing by far the greatest proportion of this cover were, in decreasing order of abundance, A. setacea, A. duttoniana and A. caespitosa.
